**QUALITY ALERT**

| Business: | MIDA Civil Engineering Ltd | | ALERT |
| Title: | Understanding of DPM/Concrete corner installation to avoid cold bridging | Reference No: | QA20 |
| Issued By: | Sam James | Issue Date: | 21/2/24 |

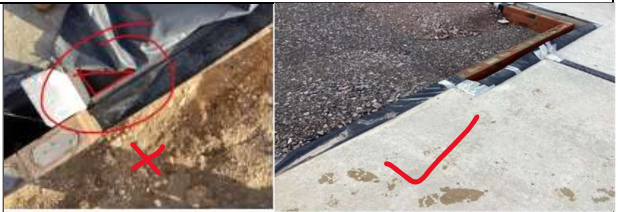
| Subject: | It has been noted on some sites the concrete floor screed is not tight into corners causing a cold bridge | | |
| Details: | Install the DPM tight into corners to avoid voids and concrete can flow tight into and join with Double sided visqueen tape underneath laps and single sided visqueen on top | | |

| Action Required: | Understand the lapping details tuck tight into corners to allow concrete to be tight to perimeter | | |
